GREEN ELECTRICITY CORRIDORS A LIFELINE FOR NATURE AND PEOPLE

**Integrated Vegetation
Management
Philosophy - Methodology**

LIFE Elia-RTE (2011-2017) (BE + FR)

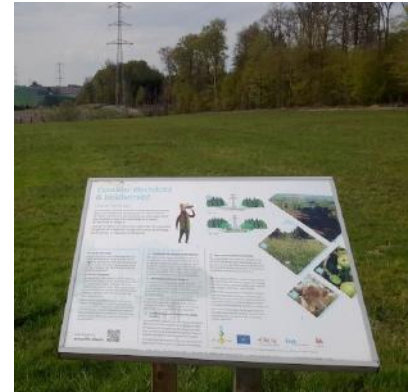
Example : Martelange – Corne du Bois du pendu

- Agreement with 2 farmers
- 2.3 ha of pasture with highlands + 6.4 ha hay meadow (6230 Natura 2000 Habitat)

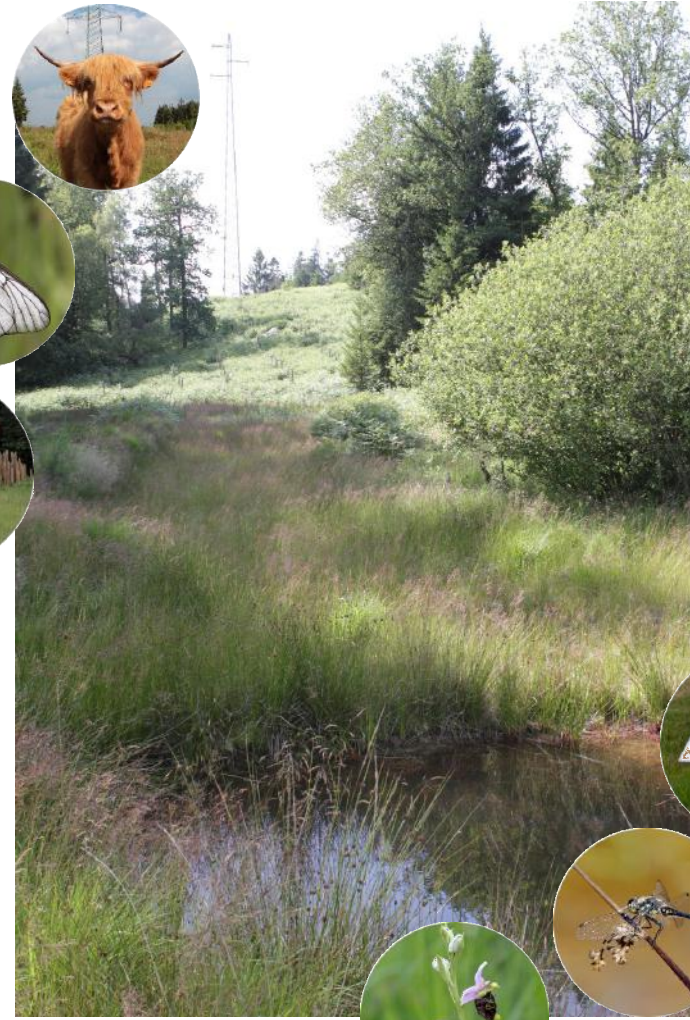
Descriptive sheets for all sites

Couvin - pâturage

Etat initial :

Ce couloir se situe sur une pente très forte et caillouteuse totalement boisée, dont la coupe doit être répétée par Elia tous les 3 à 4 ans. La mécanisation de la gestion y est par ailleurs très compliquée. Le site est identifié pour être potentiellement restaurable en pelouse calcicole thermophile très riche en biodiversité.

Action LIFE :

Pelouse calcicole pâturée par des moutons (action C6)

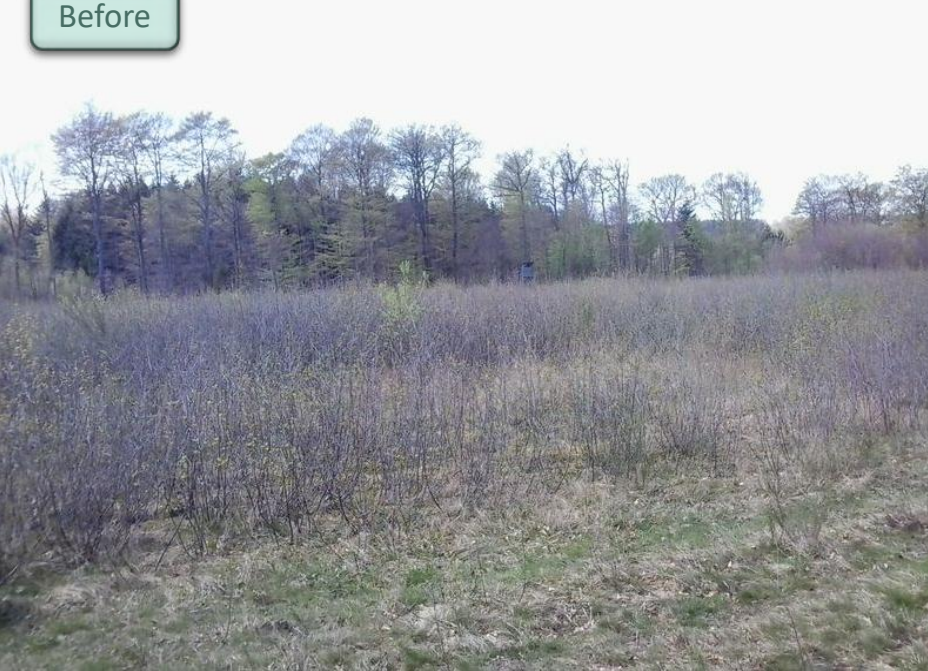
Before

Example 1 : Martelange – Corne du Bois du pendu

- Recurrent removal of tree regrowth by slashing
- Public owner (municipalities of Martelange and Attert)

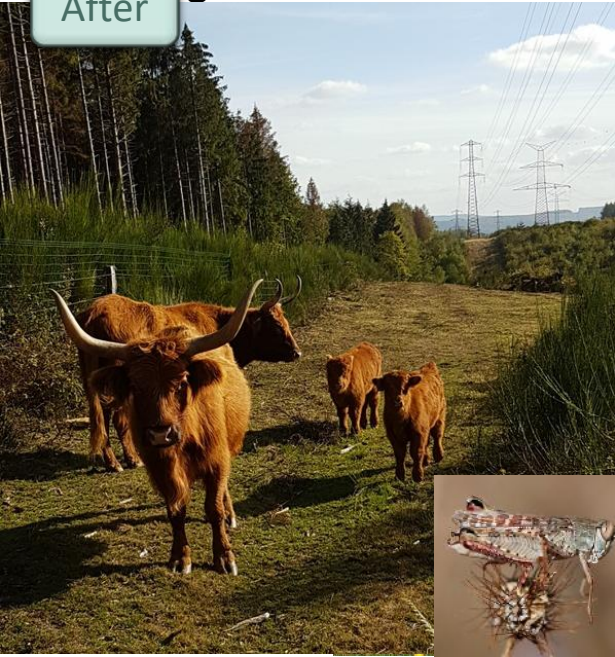
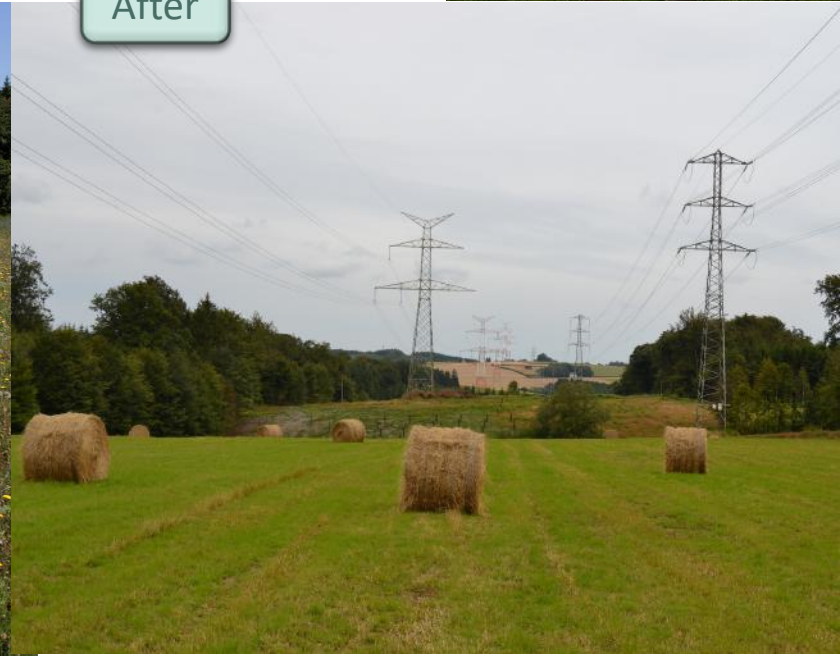
After

Example 1 : Martelange – Corne du Bois du pendu

- Agreement with 2 farmers
- 2.3 ha of pasture with highlands + 6.4 ha hay meadow (6230 Natura 2000 Habitat)

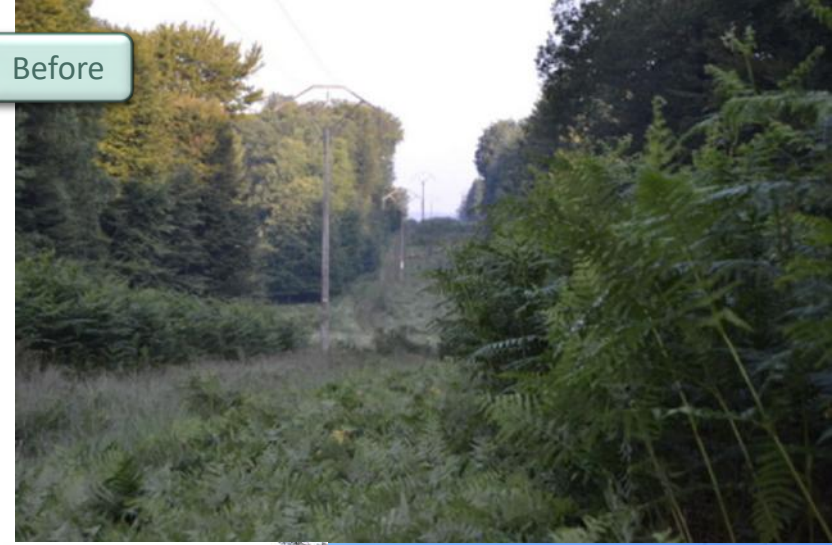
Before

Example 2 : Fays-les-Veneurs

- Corridor widening planned by Elia
- Public owner (municipalities of Paliseul and Bertrix)
- Covered with common bracken

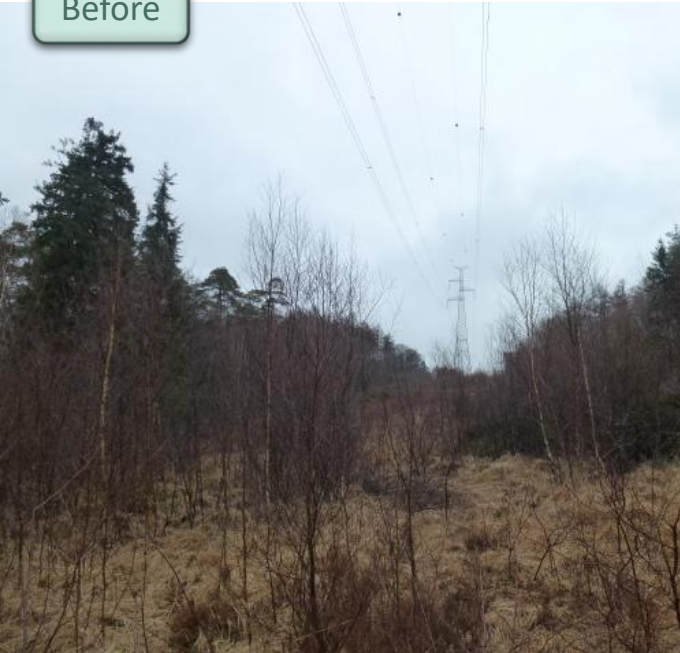
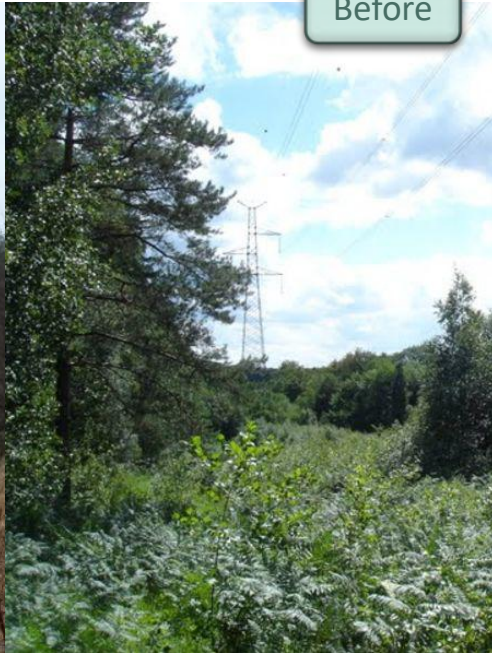
Before

Example 3 : Winenne

- Recurrent removal of tree regrowth by rotary slashing
- Steep ground
- Public owner (municipality of Beauraing + Walloon Region)

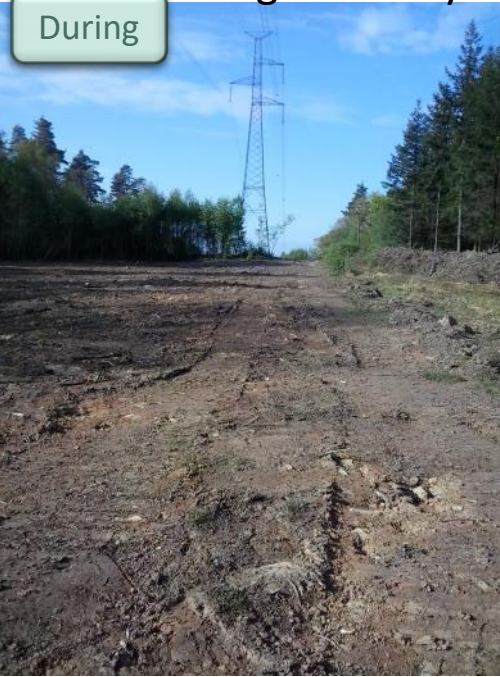
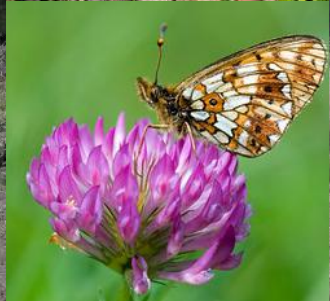
During

Example 3 : Winenne

- 4 ha heathland (4030 Natura 2000 habitat) restored by top soil scraping + ponds
- Management by the Nature and Forest Administration
